Investigation On The Causes Of Distress Affecting Perfomance Of Asphalt Pavement

ZerihunBelayneh Woldesenbet¹, Mulugeta Regassa Yimam², Mengistu Mena Kuleno³

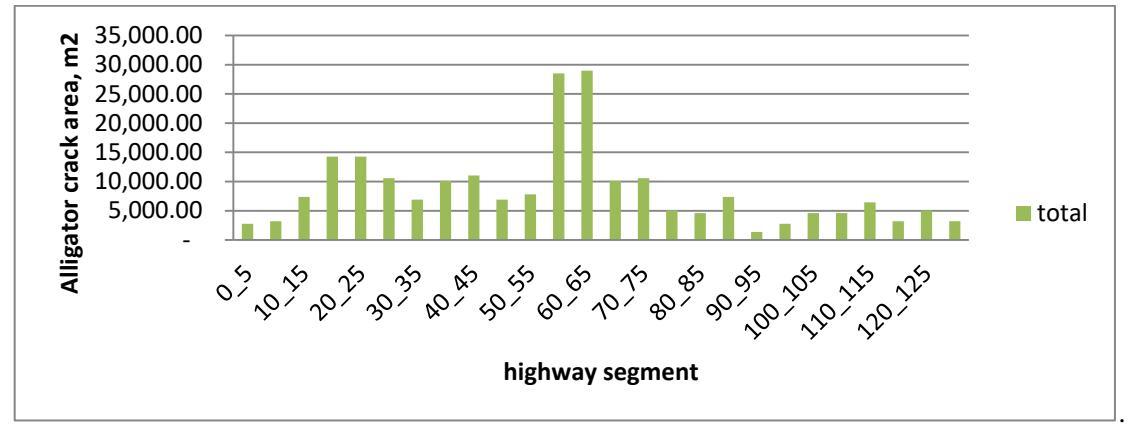
Alligator crack: - Alligator cracking may be considered a combination of fatigue and block cracking. (FHWA 2006). The general alligator crack distribution observed throughout the road stretch under study can be presented as shown in the figure 2.

Figure 1. Alligator crack distribution in the total road section.

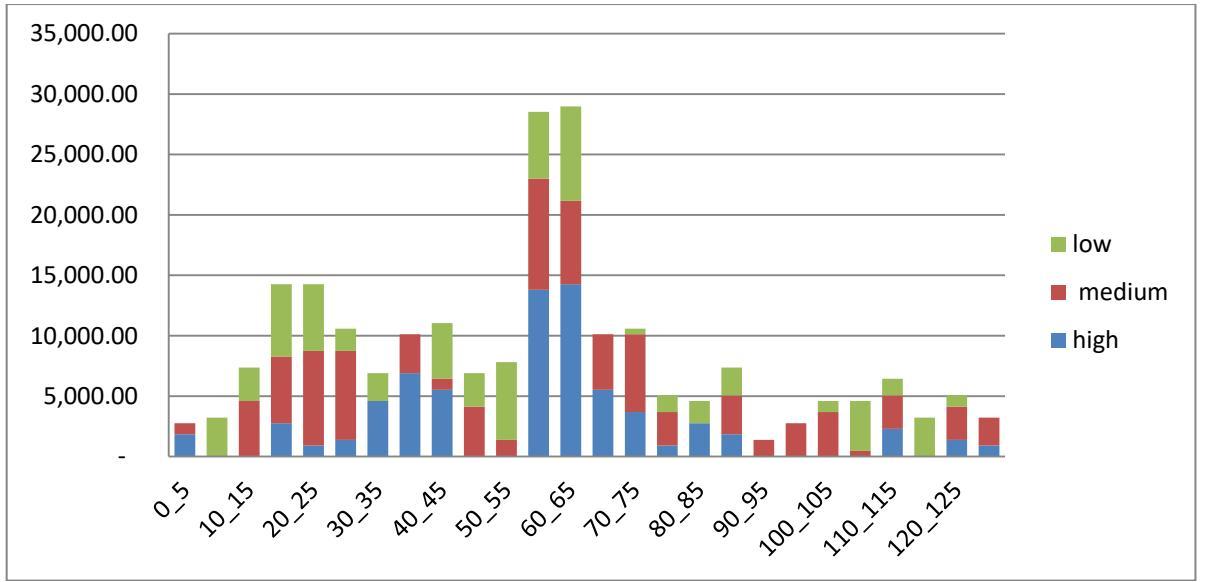
Figure 3showed alligator crack severity distribution. It can be understood that highly severe alligator crack was observed in section two of the road section. Section one has experienced relatively fewer highly severe alligator crack compared to section two, and section three has least amount of highly severe alligator crack.

Figure 2. Alligator crack severity distribution

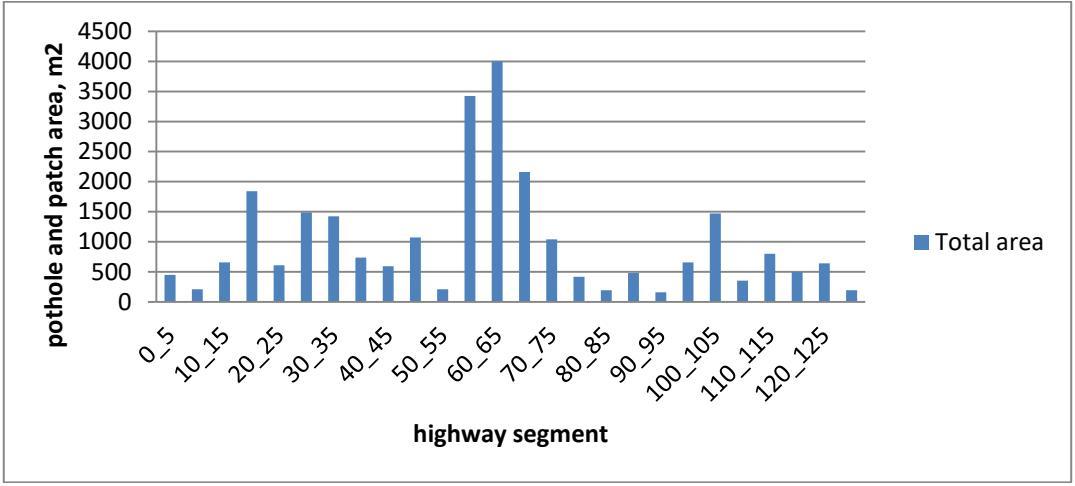
Pothole and patch area distribution in the road is presented in the figure 4.5. The figure pointed out that high intensity of potholes and patch area was observed in section two, more specifically from km 55 to km 65. Section one also has relatively high intensity of pothole and patch.

Figure 3. Pothole and patch area distribution in the road

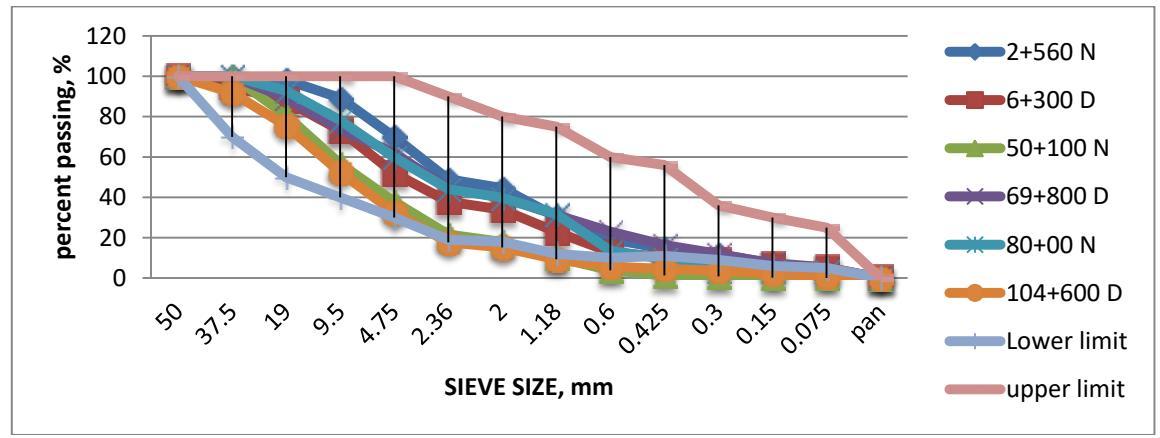
Figure 6Sub-base grain size distribution relative to ERA specification grain size distribution requirement

Material property investigation by laboratory test indicate that subgrade and sub-base materials are with finer grain size, weak CBR strength and high PI value the required value specified by ERA standard, while gradation analysis for base material shows that it is coarser compared with the standard. Bitumen content determination revealed that the asphalt concrete used were with less bitumen content than specified content by standard. From these results it can be generalized that materials used during construction were with weak engineering properties which can be listed as a major cause of failure.Longitudinal and cross drainage facility observation during condition survey has proved that drainage was one cause for distresses to occur and expand to hinder pavement performance. Traffic load analysis has proved that the existing cumulative equivalent standard axle load were much greater than the design cumulative equivalent standard axle load, and the were also concluded to be one of the major causes of distress. Investigation on the impact of distressed pavement indicates that travel speed of vehicles is highly influenced by distress. From all investigation it is understood that the existing maintenance condition is poor. Due to these minor potholes that can be easily maintained and drainage condition that can be managed easily were observed to result in low to high alligator crack and total asphalt surface failure. Therefore, in order to improve the quality of existing pavement urgent maintenance and reconstruction for section with totally failed asphalt surface at 55km – 65km shall be done considering future traffic and the importance of the existing pavement road for the community.

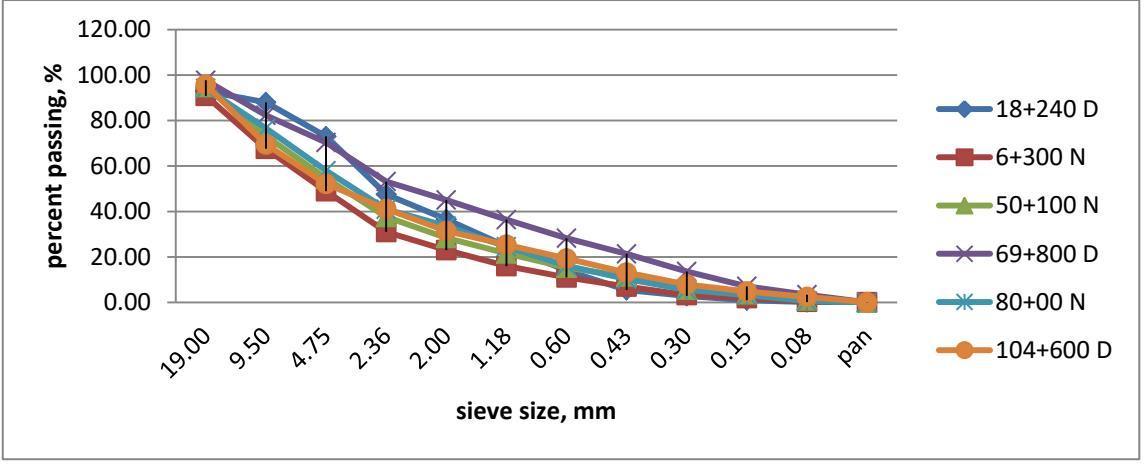
Figure 7. Subgrade grain size distribution\
